PROCEEDINGS  
OF THE  
SMRM DEGRADATION STUDY WORKSHOP

Organized by:  
The Satellite Servicing Project  
Goddard Space Flight Center

May 9-10, 1985

**SUMMARY OF THE SMRM DEGRADATION  
STUDY WORKSHOP**

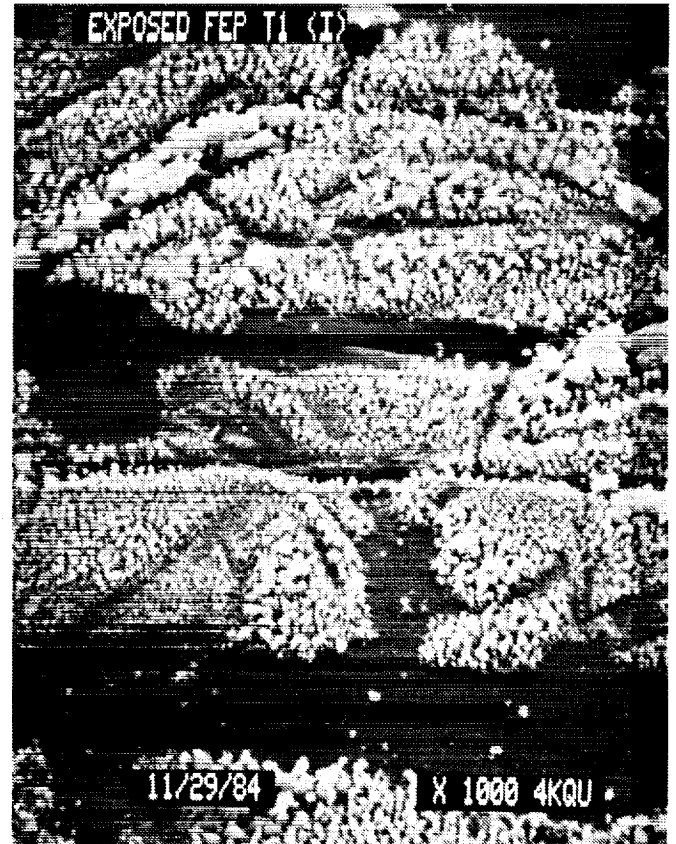
Figure 12

T1 FEP Teflon Exposed Ag/Inconel Side. The Morphology is Similar to that of the Laboratory Exposed Ag/Inconel with Ag Growing Through Cracks and Grain Boundaries in the Inconel Overcoat. At High Magnification it is Possible to Observe Regions in which the AG/I has been Totally Removed and the FEP Teflon Textured Surface is Visible.

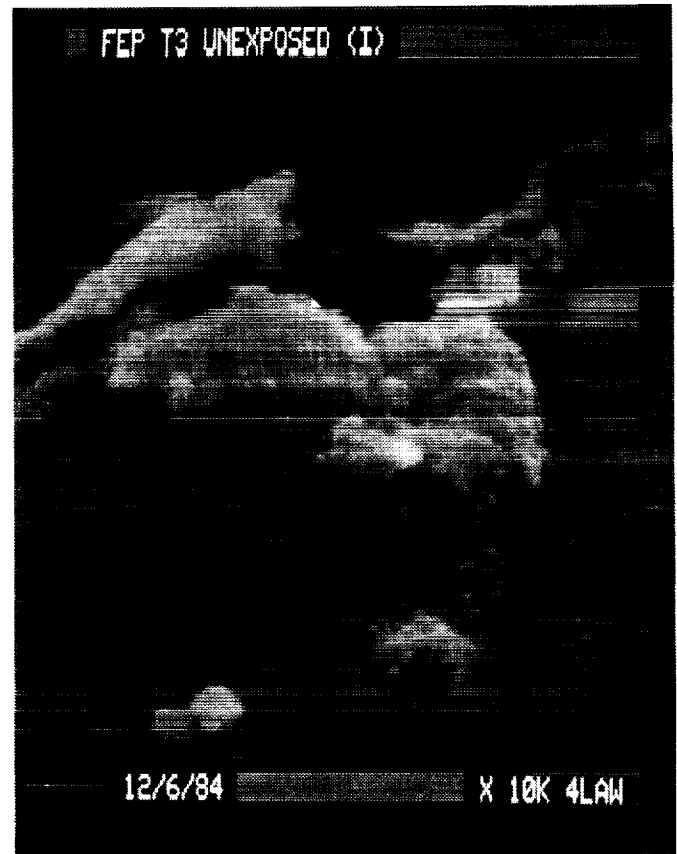
T3 FEP TEFLON

Figure 15 T3 Examples of impact craters entrance and exit in FEB Teflon.

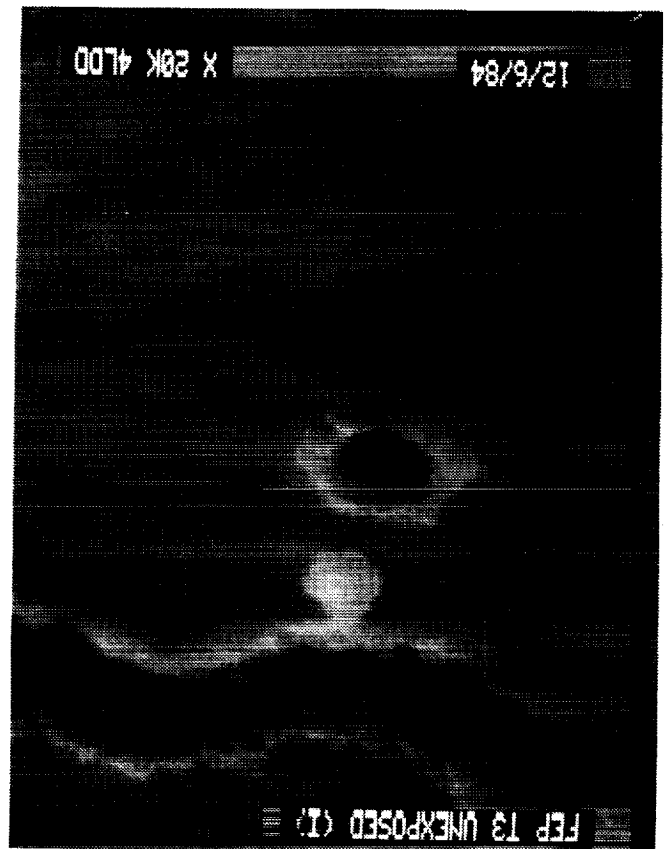
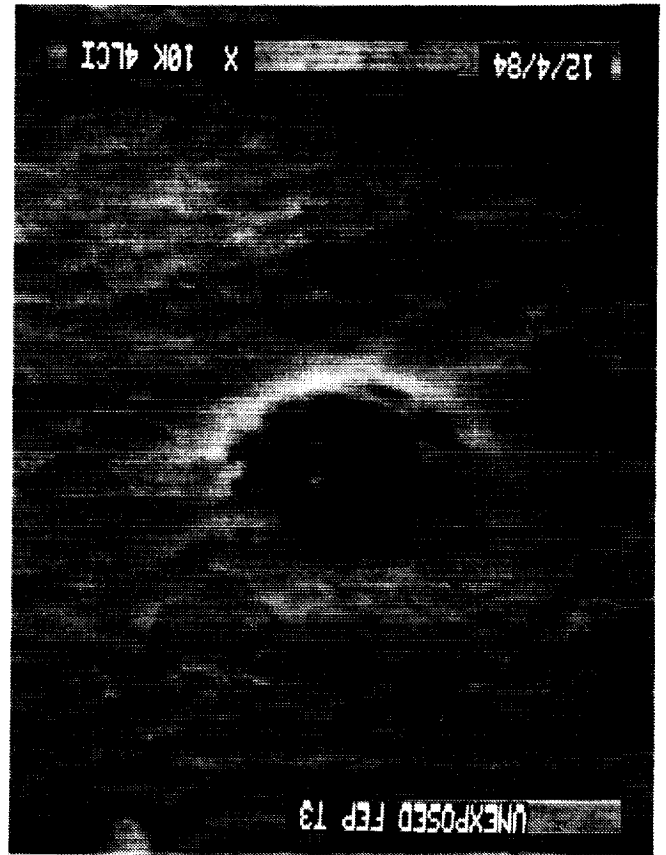
## T3 MICRO METEORITE CRATERS

Figure 18 T3 Examples of impact craters entrance and exit in FEP Teflon.

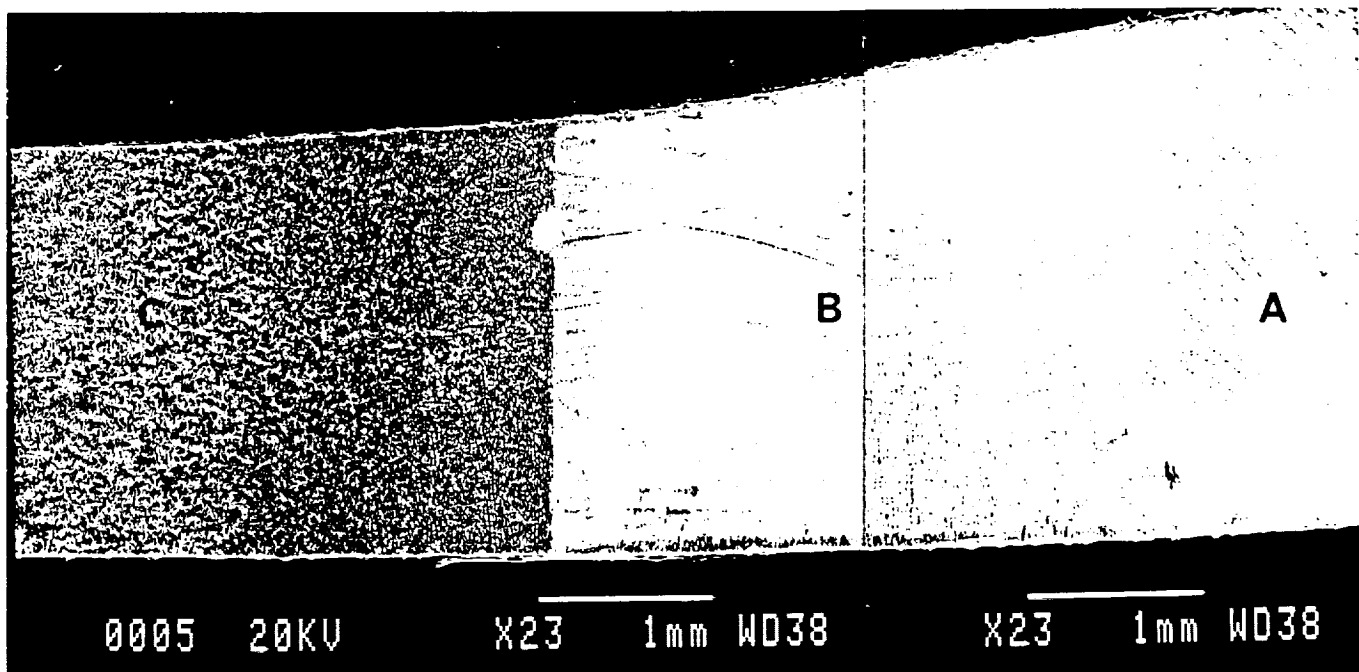
FIGURE 1

Our principal specimen is an Inconel/silver/Teflon film in which the metalized surface has been partially exposed to atomic oxygen. As shown in Figure 1, there are at least three structurally different regions (A, B and C) of interest. Region A is the unexposed area. The abundant cracks have produced a grainy microstructure with reaction product protruding from the boundary regions. As shown in Figure 2, the grain surface and reaction product are primarily silver, nickel, and carbon. Region B is transition area exposed to a moderate dose of atomic oxygen. Cracking in this region is more severe and has resulted in a greatly reduced grain size. In addition, as shown in Figure 3, the boundary region has begun to erode with reaction product being dispersed over the surface. Despite these structural changes, the EDX analysis reveals that the surface is still composed primarily of silver, carbon and nickel. Region C is the completely exposed material. The grains have largely been eroded away leaving cone-like formations. As shown in the EDX spectrum of Figure 4, silver and nickel have largely been removed. High carbon and fluorine signals characteristic of Teflon remain. Unexpectedly, significant quantities of oxygen were not detected in the areas exposed to atomic oxygen.

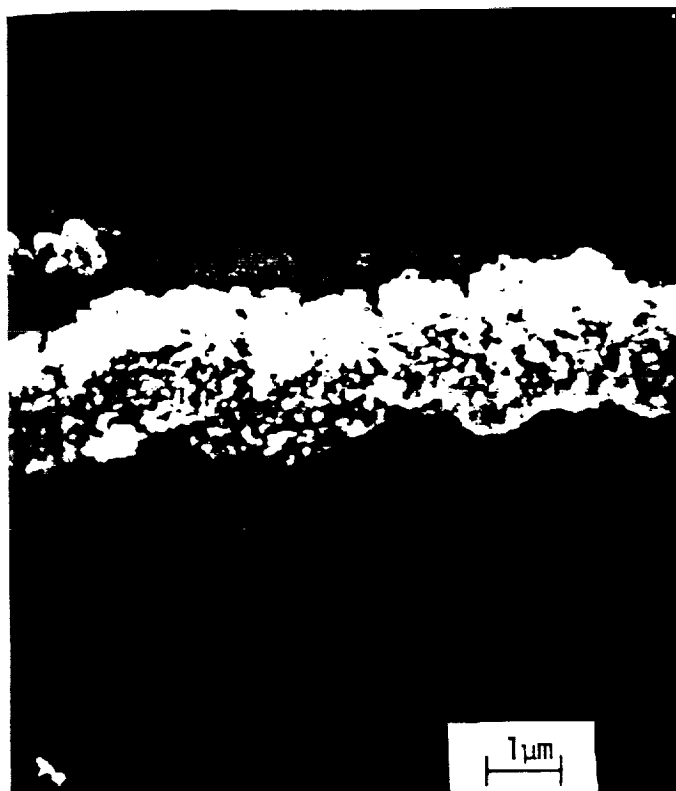
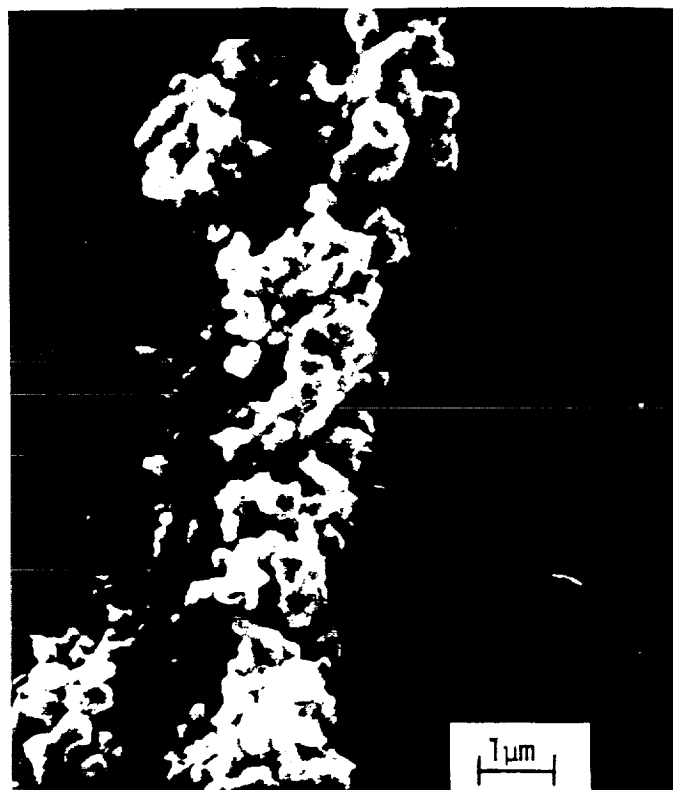
FIGURE 5

# REACTION PRODUCT PROTRUDING FROM SURFACE CRACKS

SURFACE DEGRADATION OF EXPOSED MATERIAL

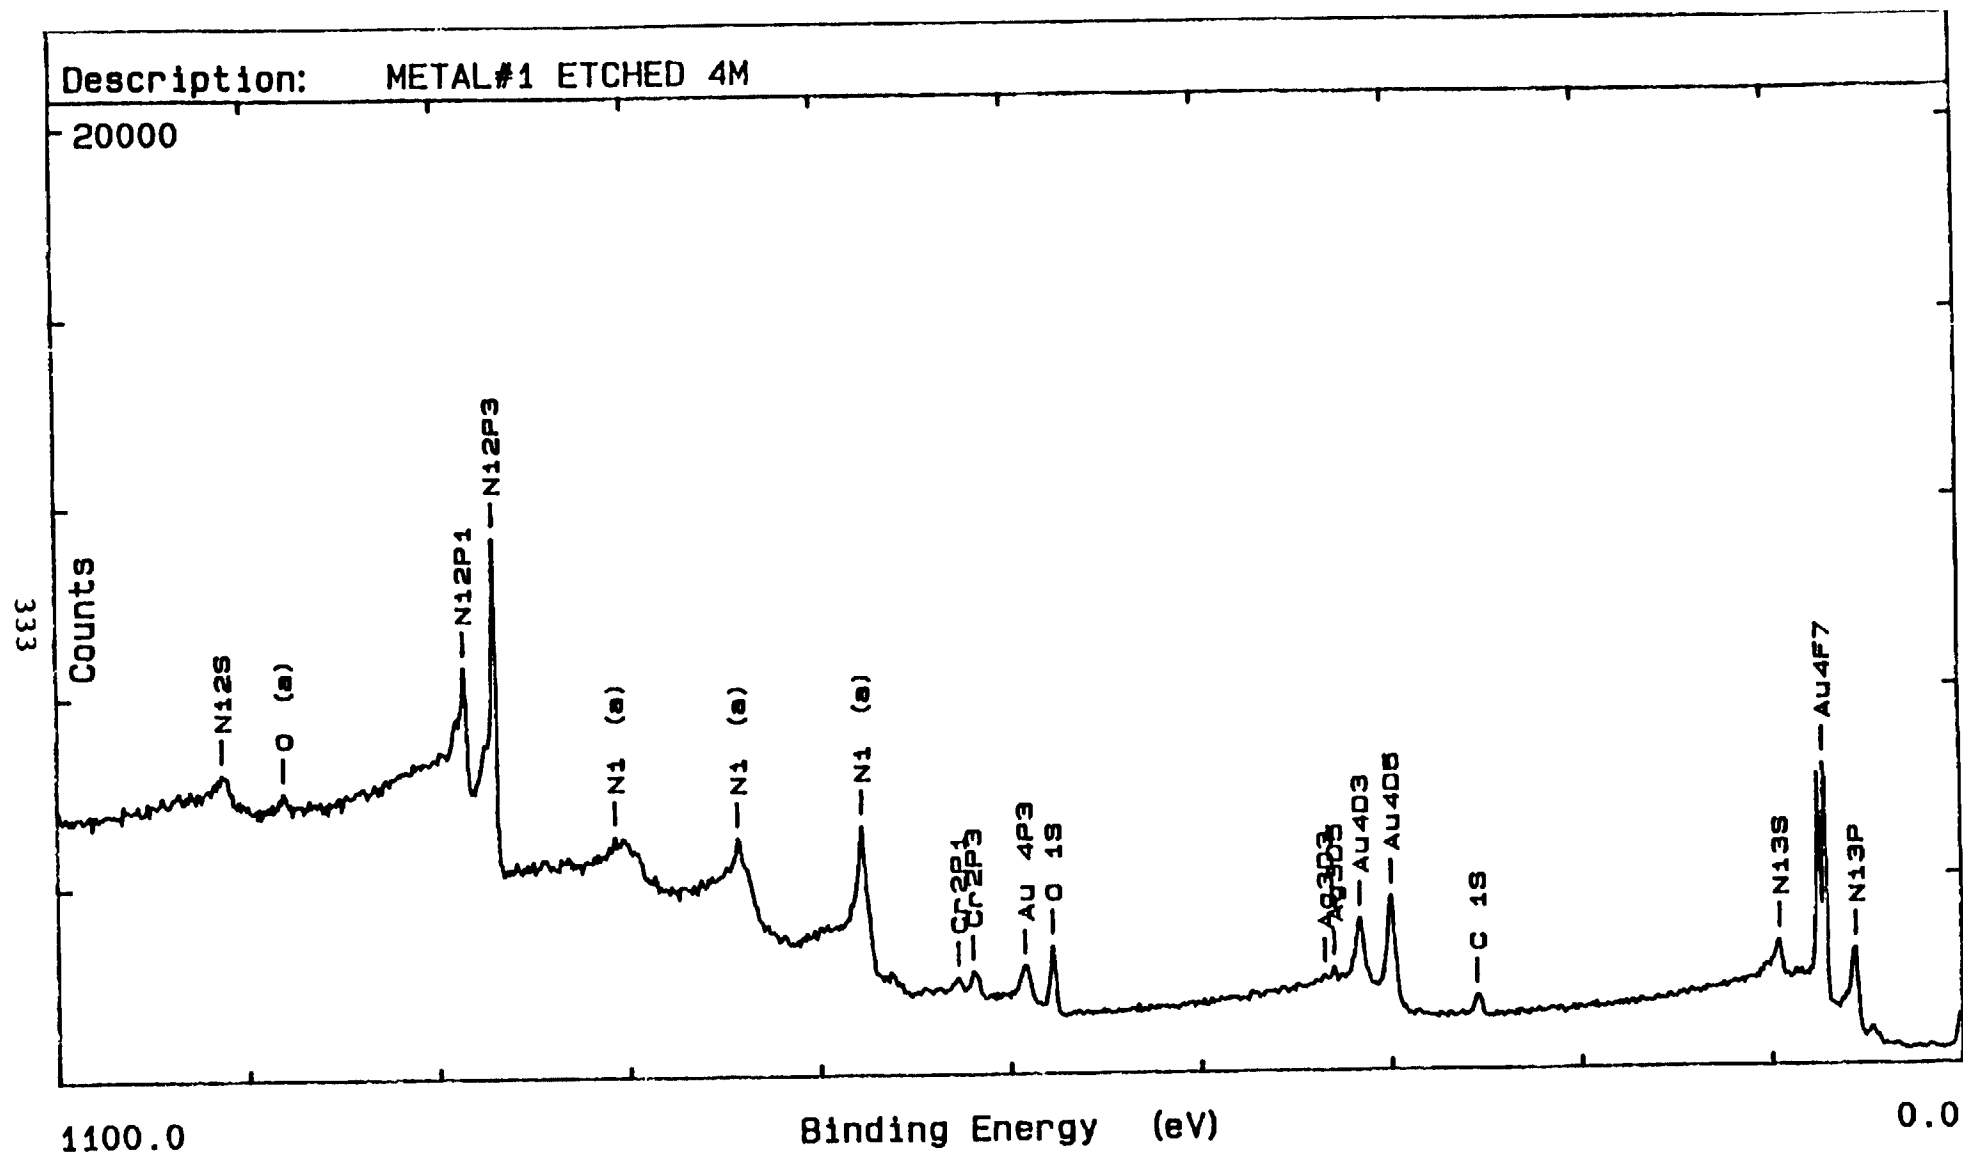
FIGURE 11

The atomic oxygen exposed and unexposed metallic surfaces were also analyzed by XPS to determine any differences in their chemical form. Prior to analysis, the samples were coated with a thin layer of Au for binding energy calibration. The XPS spectra of the unexposed and exposed surfaces are presented in Figures 11 and 12, respectively. The spectrum of the unexposed surface shows the presence of Inconel constituents (nickel and chromium), oxygen, carbon and a trace of silver. The high energy shoulder of the Ni2p3 peak, as well as the position of the oxygen peak, indicate that an extremely thin nickel oxide has been produced on the surface. The carbon peak is positioned at 284.6 eV which is characteristic of graphitic carbon.

# XPS SPECTRUM OF UNEXPOSED REGION

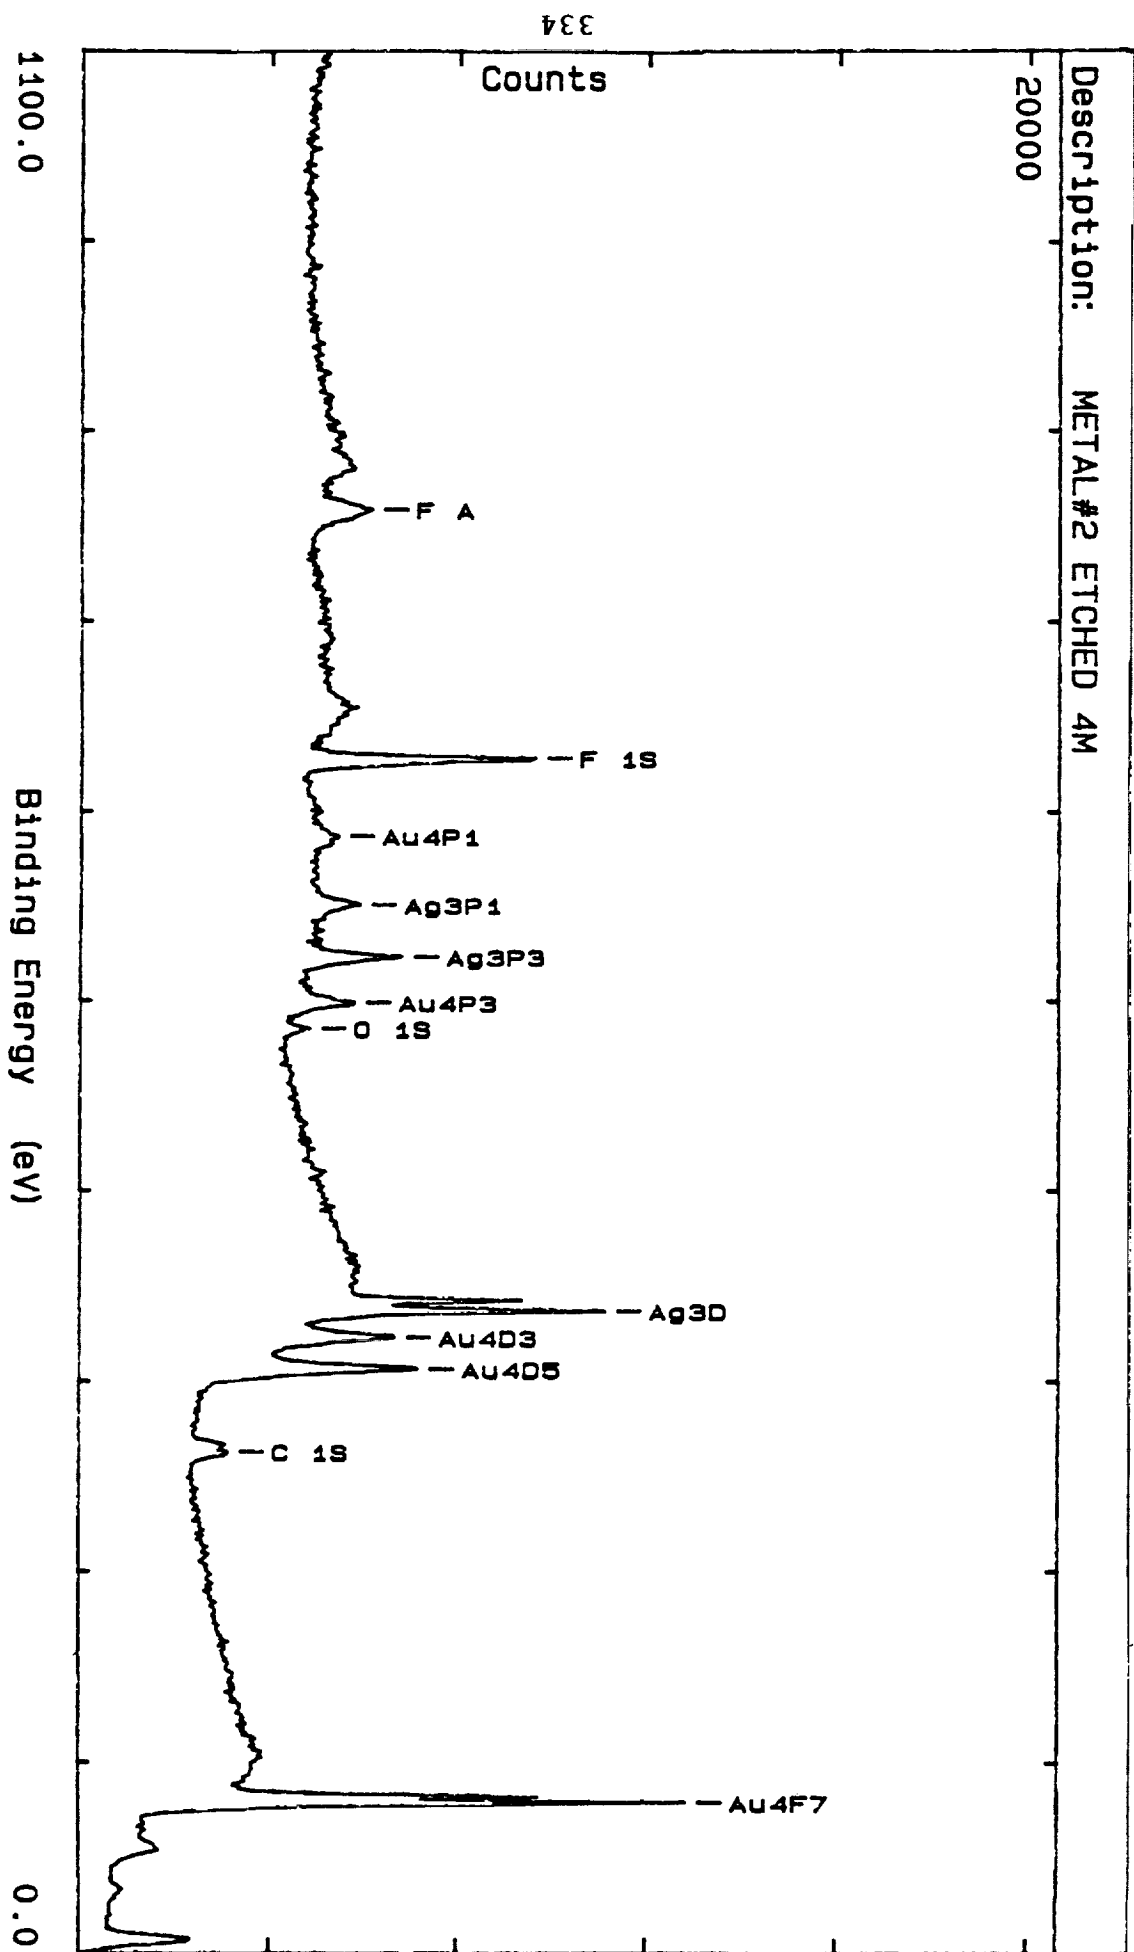
FIGURE 12

# XPS SPECTRUM OF EXPOSED REGION

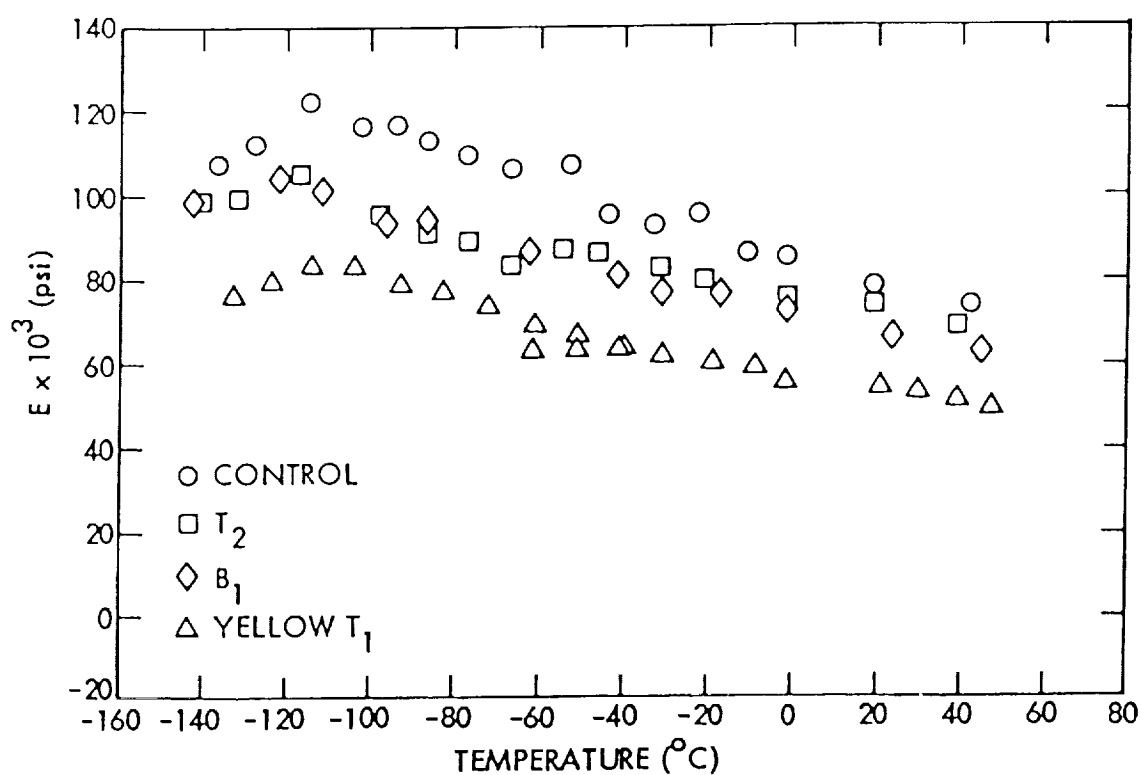
Figure 2. Plot of Tensile Modulus as a Function of Temperature

Rheovibron measurements were carried out on these samples in order to determine possible bulk property changes. Figure 2 is a plot of tensile modulus as a function of temperature. All three exposed samples exhibit loss of modulus. Both samples  $B_1$  and  $T_2$  showed 15% decrease while sample T suffered a 30% decrease, in modulus.
